CERTIFICATION TEST REPORT

TEST REPORT 15753-1
OF
400 HOUR U.V.B. TEST
OF
MOLDED PLASTIC BEZELS
FOR
GRAYHILL INC.

REPORT NO.: 15753-1
IMANNA JOB NO.: 15753
CUSTOMER P.O. NO.: PN25196
CONTRACT: N/A
PAGES IN REPORT: 3

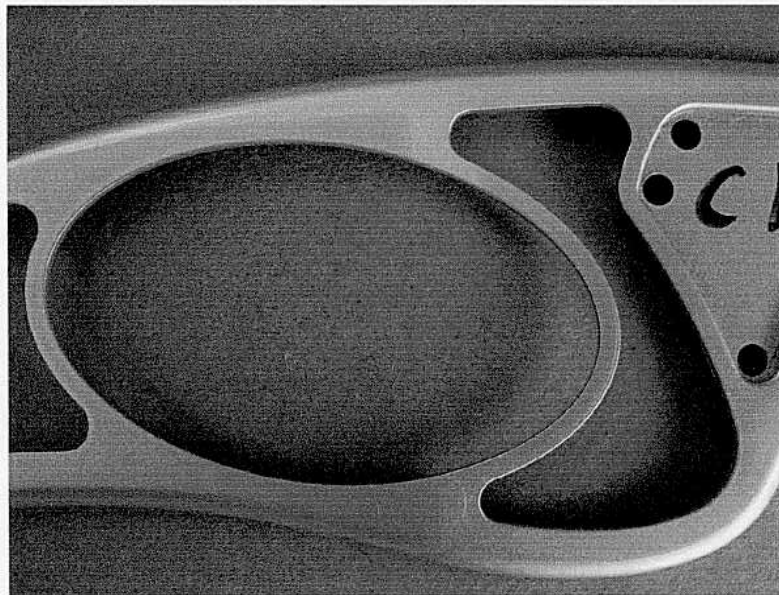
Each of the tested samples experienced changes that could be detected, visually, as a result of the 400 hours of exposure. Photos of each of the tested pieces following the test cycle follow.

Figure 1 typical test piece after 400 hr exposure

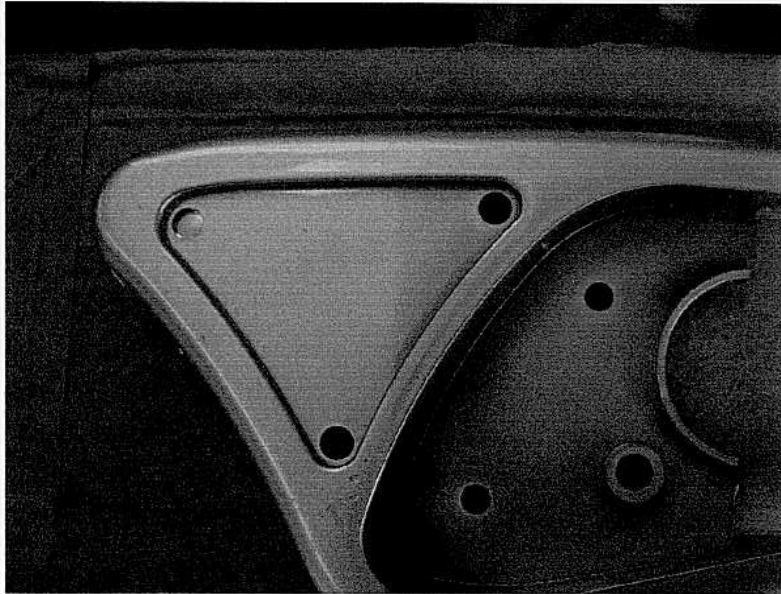
Figure 2 view of change experienced after 400 hr exposure
